Investigations of A LOW-COST ROOF for SMALL FARM BUILDINGS

**E. L. Hansen, E. D. Rodda,
and
F. W. Bauling**

Bulletin 649

UNIVERSITY OF ILLINOIS · AGRICULTURAL EXPERIMENT STATION

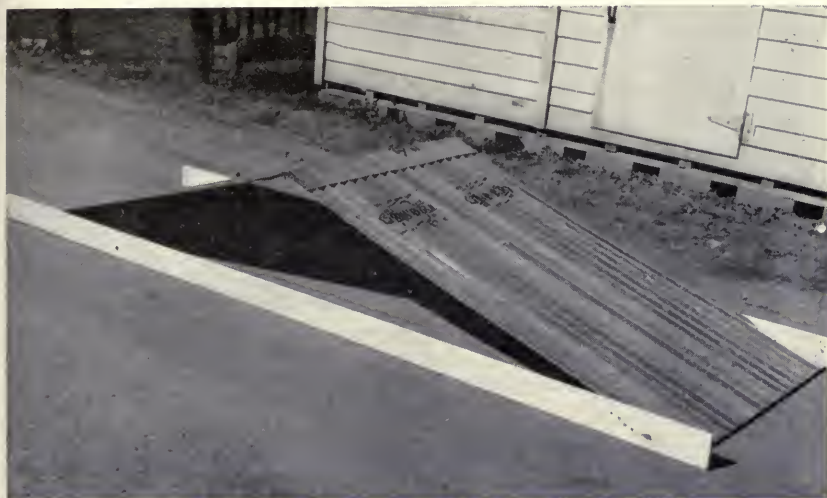
Test section, lightweight roof. Each section width of one sheet of galvanized steel or aluminum roofing with 2½-inch corrugations. (Fig. 1)

To determine minimum requirements for roofs on small farm buildings, six tests were made on lightweight roof sections consisting of only upper and lower chords. Web members usually considered necessary for support and stiffness were omitted. The upper chords were the roofing sheets, and the ties across the bottom formed the lower chords. The ties used were 1 x 6 boards on each side of the roof (Fig. 1). Each section was the width of one sheet of galvanized steel or aluminum roofing. All sheets had 2½-inch corrugations.

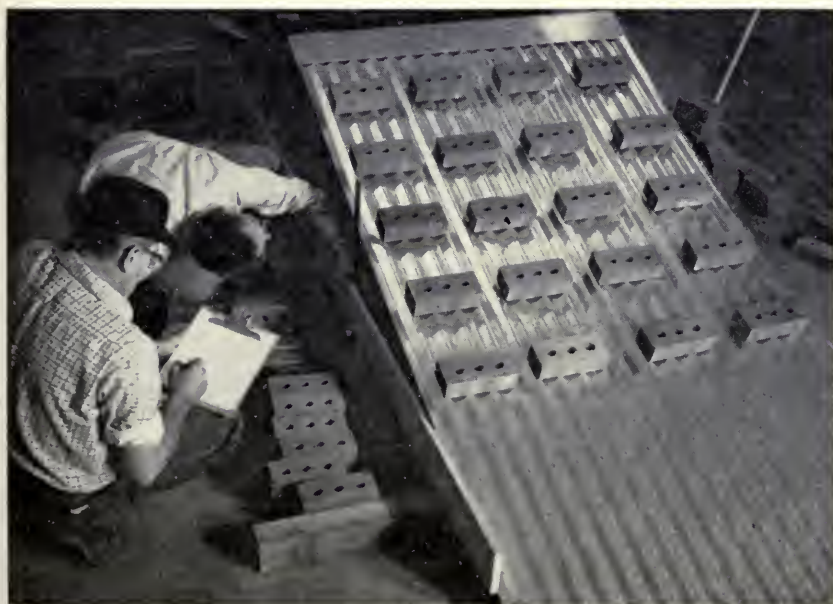
(Fig. 6)

Aluminum roof section loaded both sides; 12-foot span. Test 2.

Test 2 was made on an aluminum roof section with a 12-foot span. The sheets were .024 inch thick with 2½-inch corrugations and were fastened at the peak with ¼-inch bolts. The load was applied and the deflections measured as before (Fig. 6).

When the roof deflection averaged 2 inches, the load was 11.9 pounds per square foot of horizontal projection (Table 2), the equivalent of 22 inches of snow. After the load was removed, the roof was found to have taken a permanent set of ⅛ inch.

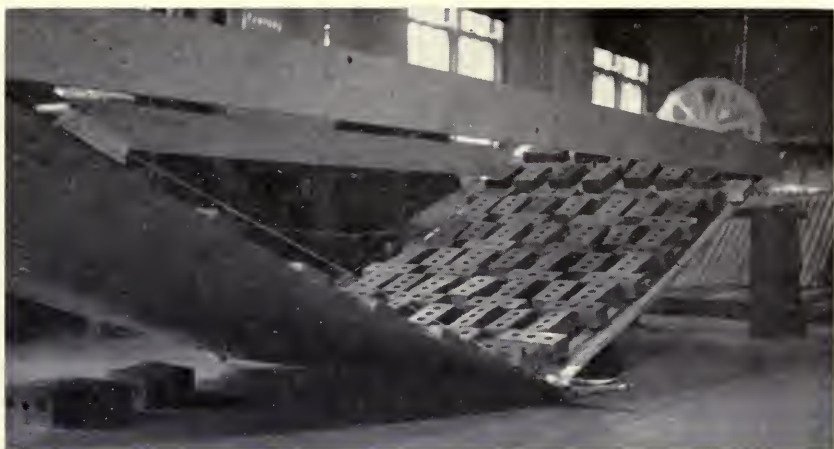
Aluminum roof section inverted; designed to simulate wind loads; 14-foot span.
Test 4. (Fig. 7)

Test 4 was conducted with the 14-foot aluminum span inverted to study the effect of an upward wind load on the roof (Fig. 7). The roof section was loaded as before. When the average deflection reached 2¼ inches, the load was 13.6 pounds per square foot (Table 2). The load was left for 72 hours. During this time, the average deflection increased less than ⅛ inch. After the load was removed, the permanent set was 11/16 inch. Part of this set may have been caused by reversing the permanent sets of the previous loadings.

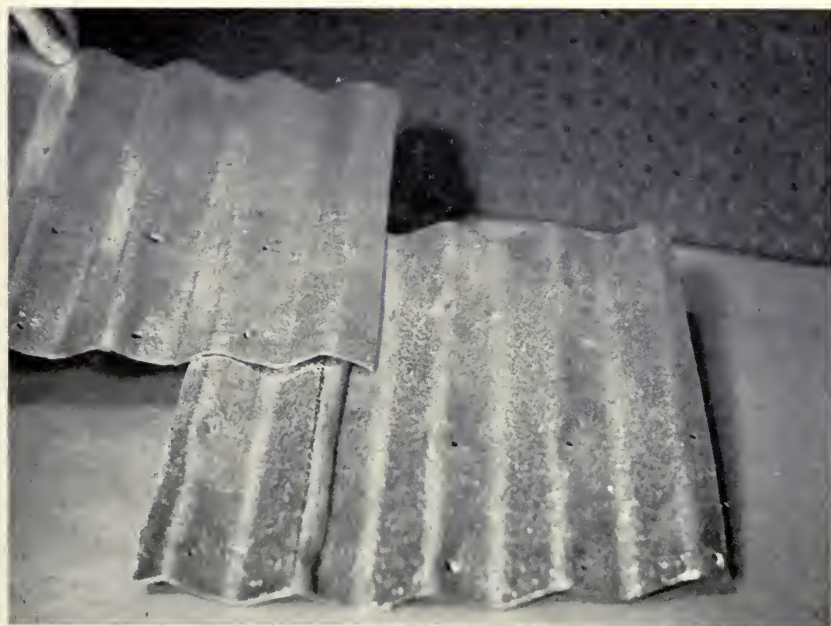
Strip caulking offset at sheet joints from rivet or screw line for weathertight seal. Does not interfere with hole drilling. (Fig. 8)

To make an actual roof weathertight, joining the aluminum sheets with aluminum rivets or the sheet metal sheets with metal screws at about 1-foot intervals with strip caulking applied at the same time would be a good practice. The caulking strip may be offset so that it does not interfere when the holes for screws or rivets are drilled (Fig. 8).

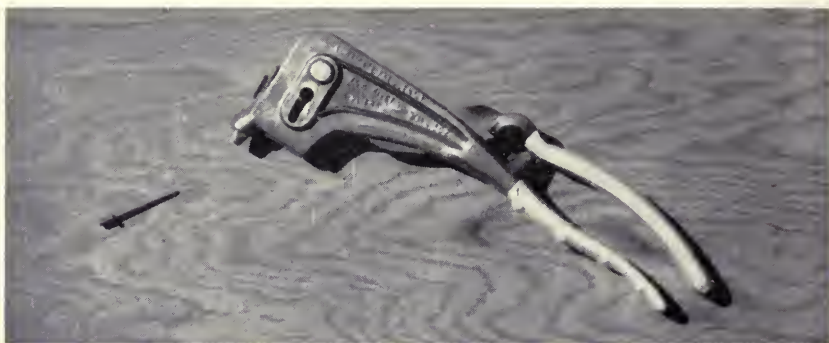
Pliers-type rivet gun for fast and easy fabrication of aluminum roof.

A pliers-type rivet gun (Fig. 9) makes fabrication of an aluminum roof fast and easy. A peak connection can be made by first fastening one plate on the bottom of the sheet, riveting through the valleys, and then securing the top plate by riveting through the top of the corrugations (Fig. 10).

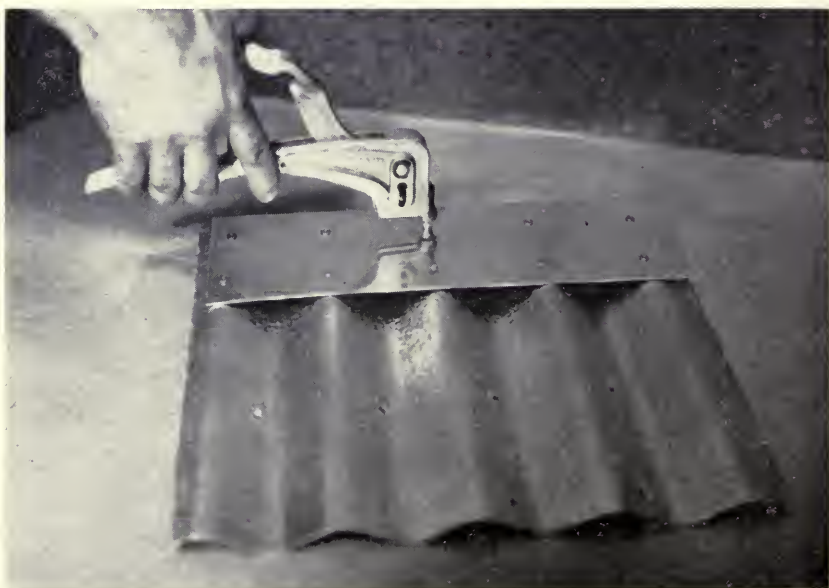
(Fig. 10)

Peak connection formed by first fastening one plate on bottom of sheet, riveting through valleys, then securing top plate by riveting through top of corrugations.

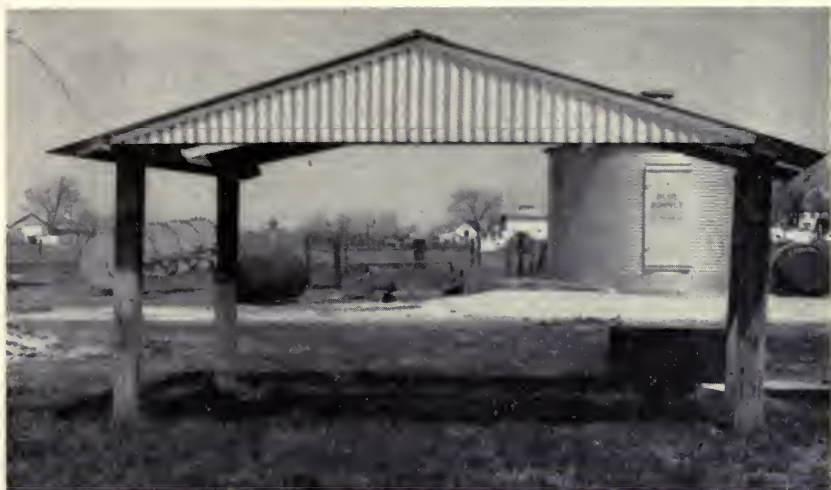
Test roof of lightweight construction used as field shade. This roof withstood the worst ice storm in fifty years without damage. (Fig. 11)

The test sections shown in Fig. 11 withstood the 1959 ice storm, the worst in fifty years. Examination has shown all parts of the sections to be in excellent condition. They show no effect of the excessive load they carried.

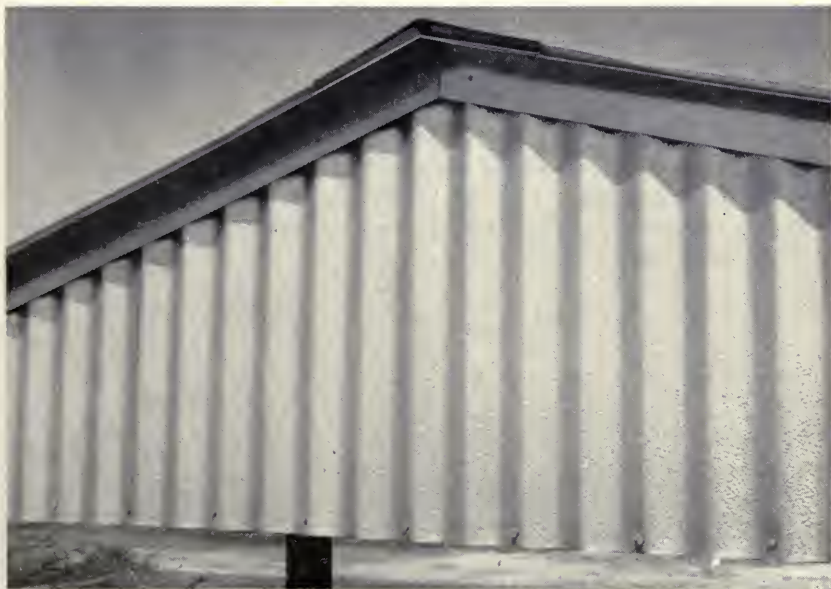
End section formed by riveting flashing or fastening with sheet metal screws. (Fig. 12)
